**L.88**

SERIES L: CONSTRUCTION, INSTALLATION AND  
PROTECTION OF CABLES AND OTHER ELEMENTS OF  
OUTSIDE PLANT

**Management of poles carrying overhead  
telecommunication lines**

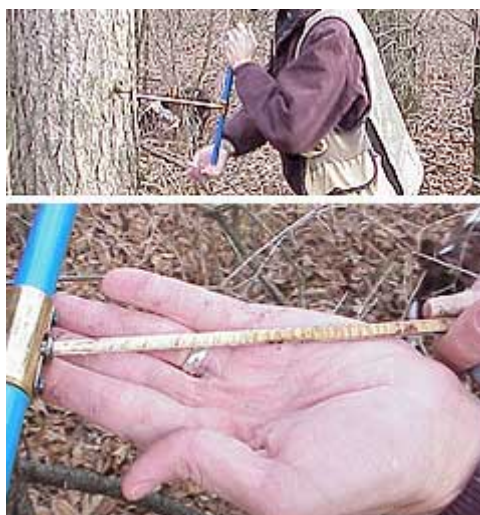
**Figure 1 – Operation with the drill probe**

Once drilled to the desired depth, an extracting "spoon" is introduced in the drill's rod, sliding it between the inside surface of it and the wooden control. Turning it completely anticlockwise causes the extracting "spoon" to be extracted with the wooden control inside it.

Sounding should always be done in the radial direction; the depth should be determined by the measurement and should be repeated for the best quantification of the attack.

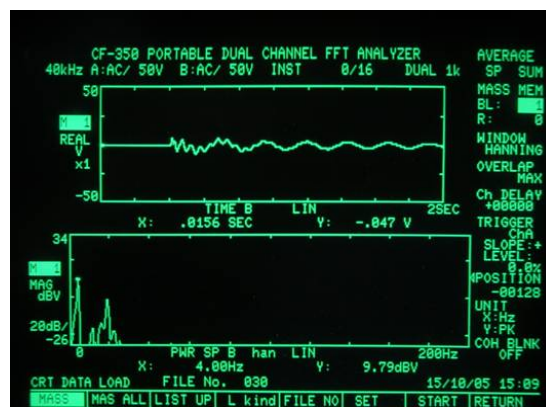
A series of field tests to obtain the resonance frequencies was performed. Figure II.3 shows typical vibration waveform and frequency spectrum for a loose sand and concrete foundation.

Figure II.3 – Typical waveforms and spectrums; a) loose sand; b) concrete

Backfill materials	Degree of compaction	Field relative density ( $t/m^3$ )	1st peak (kHz)	2nd peak (kHz)
Sand	Loose	1.496	1.5	13.5
	Moderate	1.588	2.0	14.5
	Dense	1.654	4.0	17.0
Crushed stone	–	N.A	4.0	17.5
Concrete	–	N.A	4.0	18.5

It is found that the 1st peak resonance frequency is closely related to the pole's foundation strength. If the 1st peak resonance frequency is determined as a reference value, we can identify and evaluate unknown pole foundation quantitatively by comparing the 1st peaks.
